MODIFICATIONS TO THE TUBE-LAUNCHED, OPTICALLY
TRACKED, WIRE-COMMAND MISSILE LAUNCHER FOR
THE BRADLEY FIGHTING VEHICLE SYSTEM

Report Number 98-165

June 25, 1998

Office of the Inspector General
Department of Defense

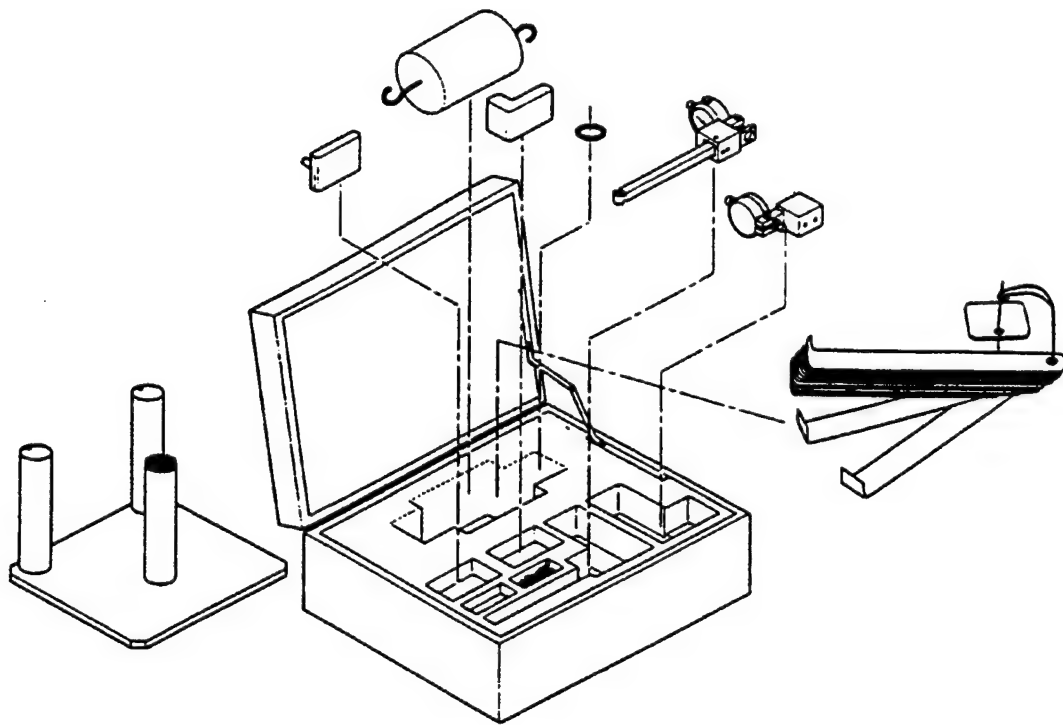
Figure 2. Switch Adjustment Gauge Set

ACU Final Assembly and Testing. Final assembly and testing of the ACU requires a switch adjustment gauge set, part 1366078, to ensure proper alignment of the ACU. The gauge set comprises gauge assemblies, tools, and fixtures as shown in Figure 2.

The gauge set is used to align and test umbilical and motor stop switches within the ACU. Those switches must be set to precise tolerances to satisfy design specifications and meet minimum in-process quality assurance inspection points required by the DMWR.

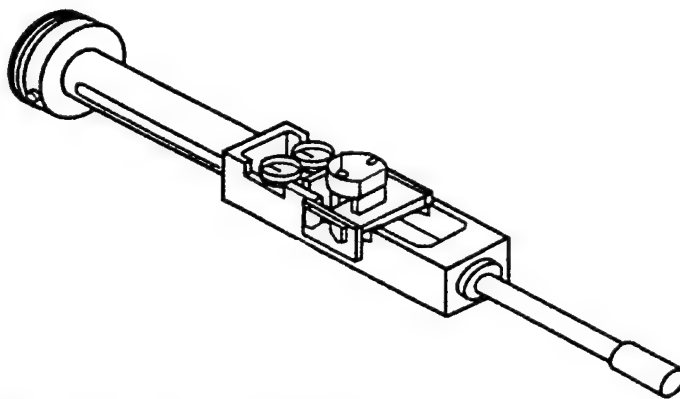
Figure 5. Setscrew Adjustment Gauge

Setscrew and Stop Block Adjustments. A setscrew adjustment gauge, part 12295912-40101-5 (shown in Figure 5), is required to perform the setscrew

and stop block adjustments to ensure that they meet the design specifications. The setscrew is to be set between -0.0005 inches and 0.0005 inches; and the stop block is to be set between 0.002 inches and 0.001 inches.

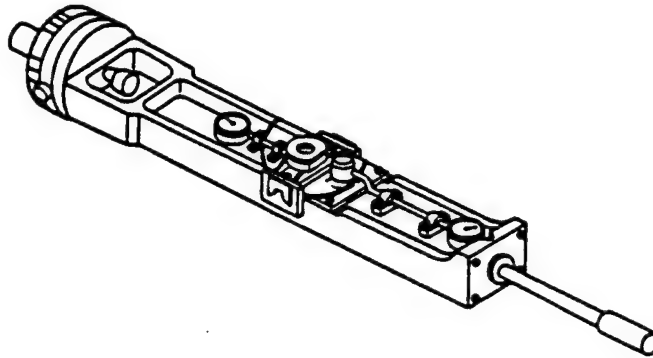
Figure 6. Boresight Alignment Fixture

Holdback Pin Plunger and Umbilical Connector Distance Tests. The distance test is performed to ensure that the holdback pin plunger and umbilical connector travels the minimum required distance. The minimum distance for the holdback pin plunger is 0.350 inches, and for the umbilical connector 0.457 inches. The DMWR requires the use of the boresight alignment fixture (shown in Figure 6), part 12295912-40101-6, to perform this test.
